ACCID/09272012/01-8

**DIRECTORATE OF AIRCRAFT ACCIDENT INVESTIGATIONS
ACCIDENT REPORT – EXECUTIVE SUMMARY**

Aircraft Registration	V5-HTZ	Date of Accident	27 September 2012		Time of Accident	15:00 UTC
Type of Aircraft	BELL LONG RANGER		Type of Operation		Aerial Survey/observation flight	
Pilot-In-Command License Type	CPL Helicopter	Age	49	License Valid	Yes	
Pilot-In-Command Flying Experience	Total Flying Hours	8402.8 hrs		Hours on Type	123 hrs	
Last point of departure	Henties Bay					
Next point of intended landing	Walvis Bay					
Location of the accident site with reference to easily defined geographical points (GPS readings if possible)						
10 NM north of Walvis Bay airport						
Meteorological Information	Wind: SW, Wind speed: 15 knots, Visibility: ≥ 10 Km, Temperature: 25°C Cloud cover: Clear, Cloud base: Nil, Dew point: Not known					
Number of people on board	1 + 2	No. of people injured	0	No. of people killed	0

AIRCRAFT ACCIDENT REPORT

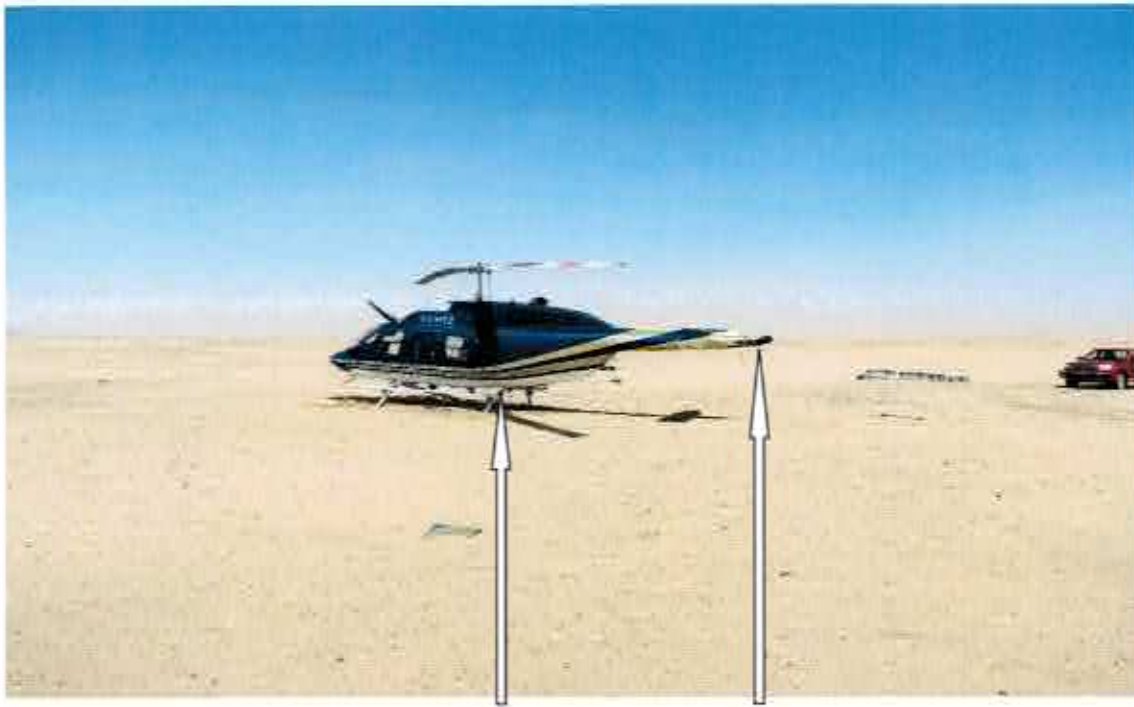
- 1.12.1 The aircraft was substantially damage. The main transmission system was found damaged and the tail boom rear end section was cut off completely by the main rotor blade. The parts from the tail boom were scattered in a radius of about 30 metres from the helicopter.

Figure 1. A photo showing the aircraft where it landed and the damage to the tail boom section

2.2.6 After the engine shut down in flight the pilot executed an autorotation for landing however after a safe landing the main rotor blade struck the tail boom rear end section cutting it off completely.

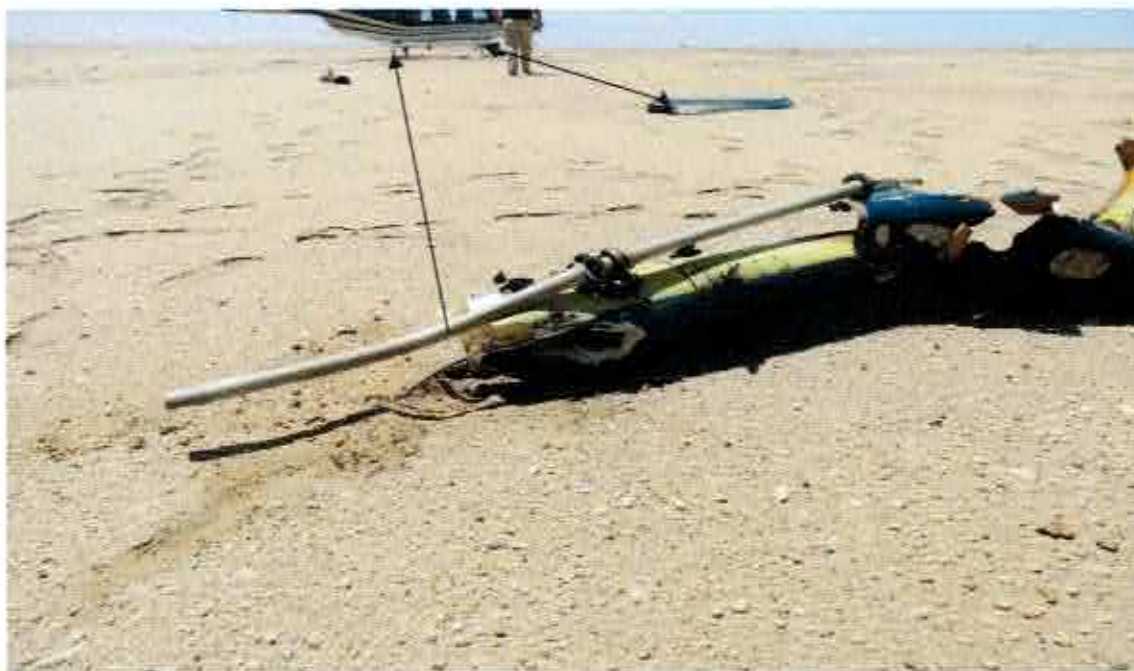
Figure 2. This photo shows scattered parts from the tail boom section at a radius of about 30 meters away from the helicopter and most of the parts were found on the right hand side of the helicopter when looking from the rear into the direction where the helicopter is nose facing that is also the direction of rotation of the main rotor blade which is counter clock wise when looking at the rotation of the blade from the top of the rotor mast.

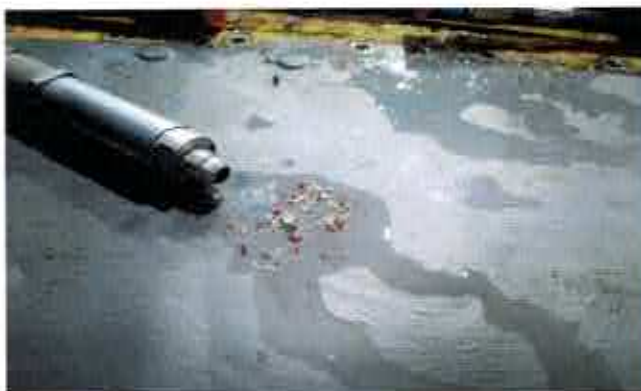
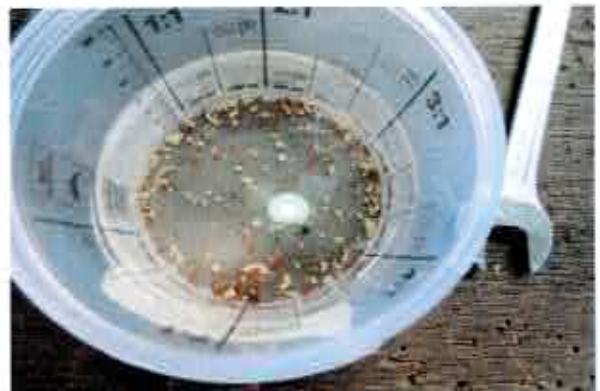
2.2.7 There was 300 pounds (166.6 litres) of fuel on board the aircraft after the accident and that fuel was enough for the remaining of the flight to Walvis Bay Airport which was around 10 miles from the accident site. However there was a concern of how the aircraft has been refuelled because the investigation found that sometimes the aircraft was refuelled from unsealed refilled drums which can cause fuel contamination. Refuelling from non sealed refilled drums that are being transported over distances and refilled several times experience shows that fuel becomes contaminated from the moisture and this causes the coating inside the drums to peel off and contaminate the fuel.

3.1.8 After the inspection on the fuel system was done by NAC in South Africa there was contamination in the form of debris found in the fuel system.

Figure: 3 the two pictures shows clearly the fuel contamination found during the investigation.

3.3.1 Fuel contamination
